## Circuit for Flashing Light Signals

## Avoiding Light-Out Signal Failures

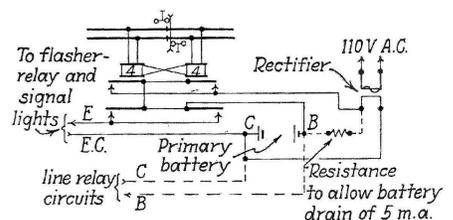
The accompanying sketch illustrates a simplified circuit arrangement for a flashing-light signal using primary battery for standby power. The rectifier is adjusted to the operated load, the output circuit being run through two pairs of back contacts in the interlocking relay in a parallel-

Details of crossing-signal circuit—Dotted lines show optional variation

series arrangement. The primary battery is connected between the two pairs of relay contacts making the rectifier and the battery operate in parallel, only while the signal is in operation, both being normally on open circuit.
