Accident at Interlocking

ON September 11, at Odin, Ill., an eastbound Baltimore & Ohio freight train occupied a crossing and was struck by a southbound Illinois Central passenger train. A summary of the report of the Bureau of Safety concerning this accident follows:

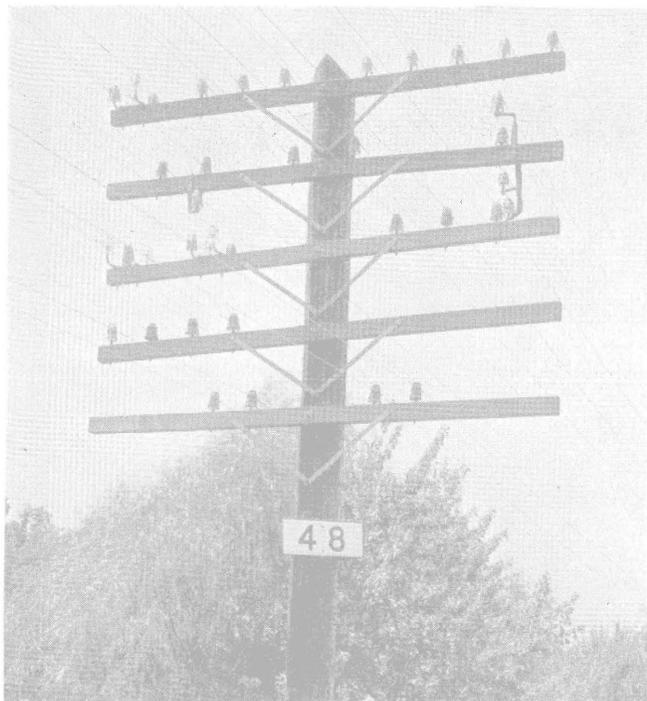
Typical pole illustrating point-type transposition bracket used in the 30-kilocycle transposition

with other circuits, 30-kilocycle transposition layouts were installed on some of the lines.
