Automatics

THE Chicago, North Shore & Milwaukee has installed automatic block signals on 3.5 miles of double track between Indian Hill, Ill., and Glencoe. This installation was made following the completion of a grade crossing

Special gauntlet track signal control circuits are a feature of recent installation on new double-track electrified line

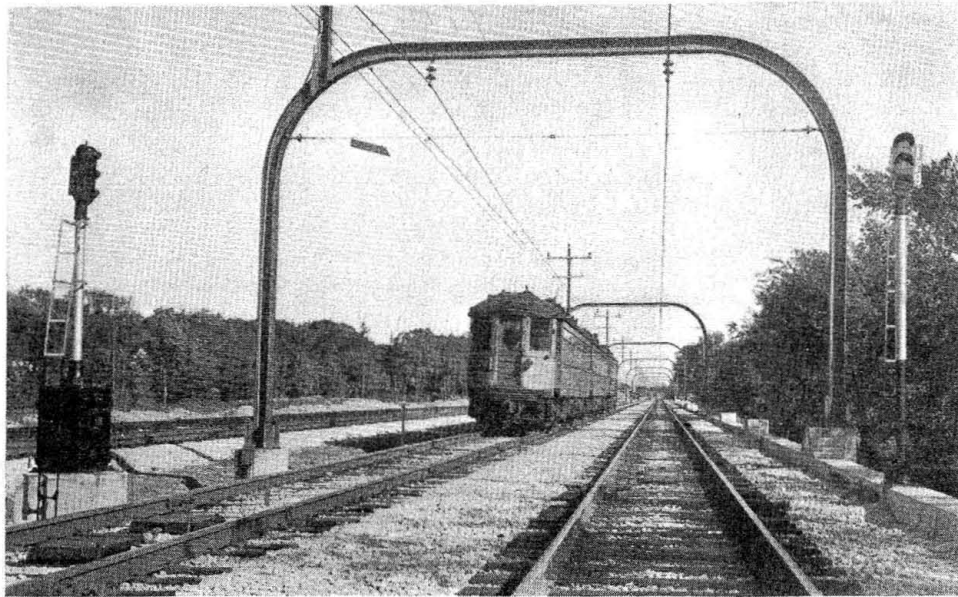
The signals had to be so located with reference to the catenary structures that there was not clearance for backgrounds

columns which support the suspension trusses are located 9 ft. from the center line of the nearest track. The signals are mounted on masts 8 ft. 6 in. from the center line of the nearest track. Unlike former color-light signal installations on the North Shore, no backgrounds are provided on these signals. If the signals were further to the side to permit the use of backgrounds, the columns and bridge piers would obstruct the view of the signals.

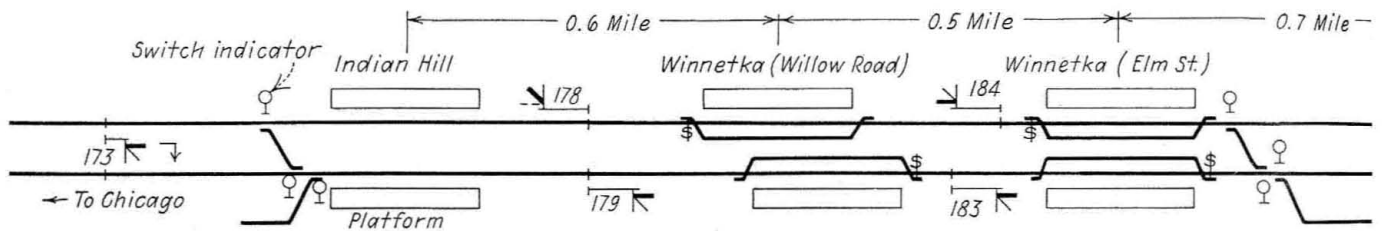
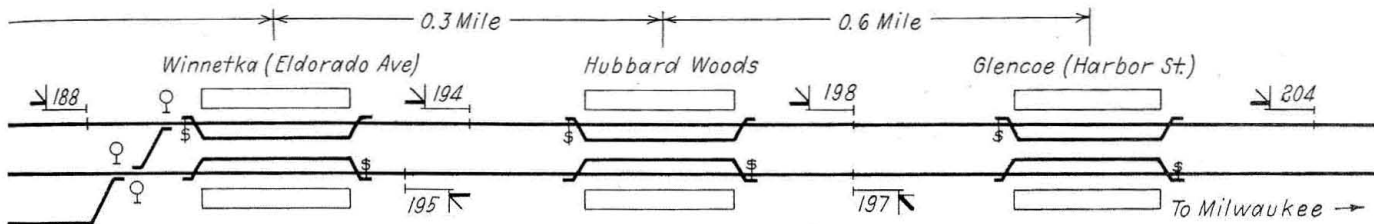
Track and signal plan of

the new signaling territory

The newly signaled territory in-

clude six passenger stations, Indian Hill, Willow Road, Elm Street, Eldorado Avenue, Hubbard Woods and Glencoe, all of which are the high-platform type, except for Indian Hill. The passenger cars are of a standard width of 8 ft. 10 in., and the platforms are constructed 4 ft. 8 in. from the center line of track to the edge of

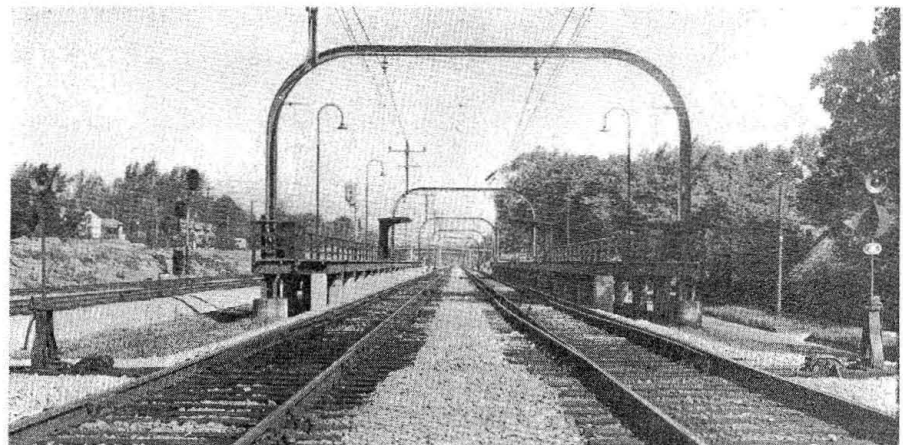
Gauntlet tracks extend through the limits of the station platforms to provide full clearance for freight cars

the platforms accordingly. The result is that the platforms will not clear freight cars or service cars of the railroad. In order to move such cars past the station platforms, a detour track in the form of a gauntlet was con-

structured on each main track at each station, the rails of the gauntlet being 12 in. farther from the platform than the corresponding main line rails. The switch at the entering end of each gauntlet track is operated by a hand-throw stand, and the leaving end by a spring switch. If the stations were built to permit both passenger and

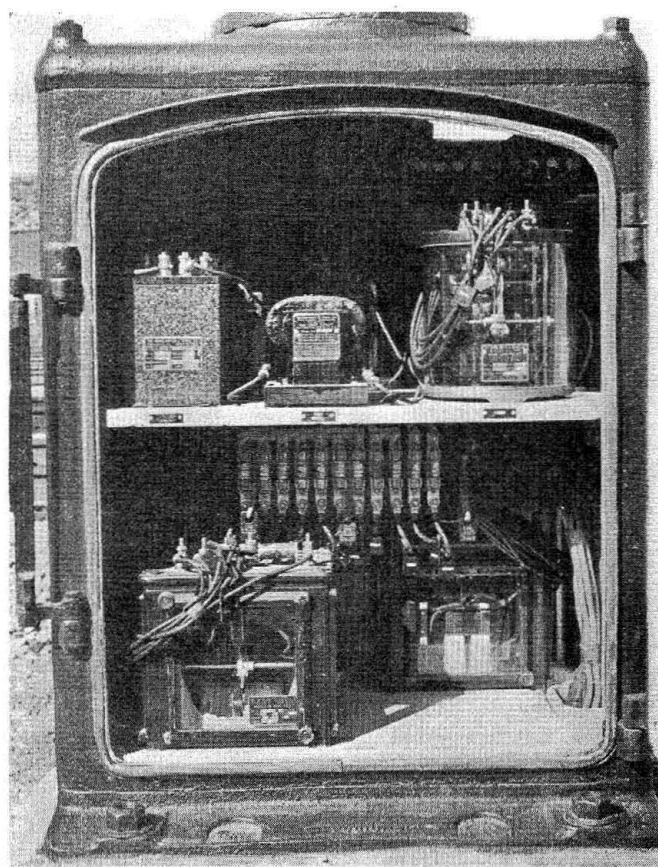
The relays, transformers and other apparatus in case
