## A Collision Despite Automatic Signals

## Bonding a Consideration In Accident Caused by Broken Rail

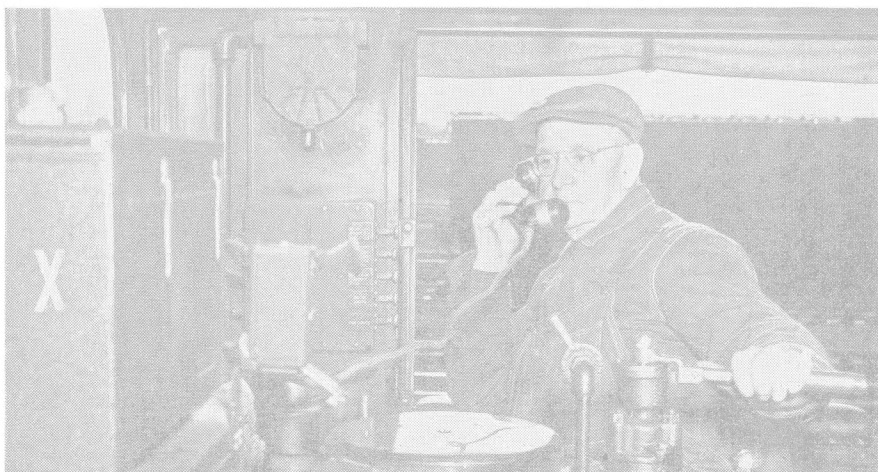
In the locomotive cab, X marks the case containing the electronic equipment
