# Signals Direct Trains at Junction

## On the Denver & Rio Grande Western

## and the Denver & Salt Lake

**Levers on small panel control signals, thus reducing number of train stops and improving safety within junction area where train speeds are slow**

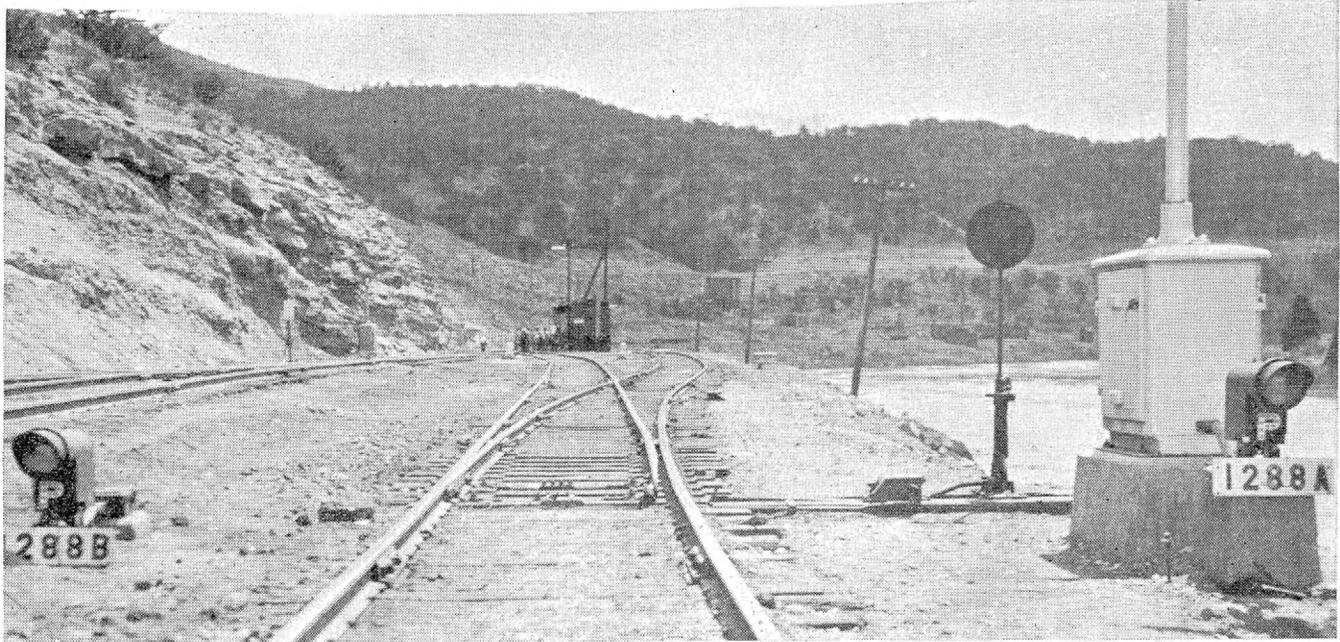
View looking east with switch No. 4, in the foreground, lined for the river track

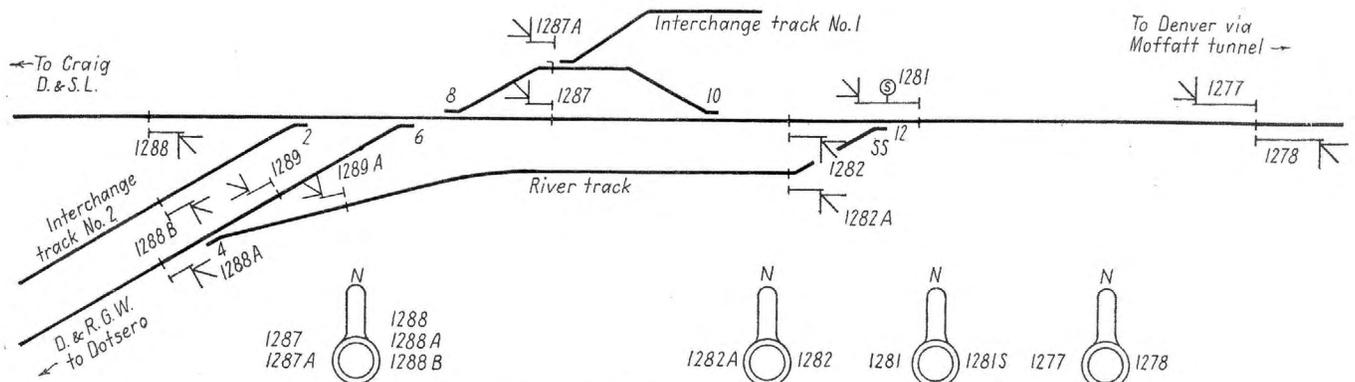
Track and signal diagram of the interlocking with symbols showing the lever numbers

All of the switches shown in the accompanying diagram, are equipped with ordinary hand-throw stands, and, in addition, switch No. 12 at the east end of the "River" track also has a spring switch mechanism.

Switch No. 6, the junction between the D. & S.L. main line and the D. &

reversed to the D. & R.G.W. Automatic block signal 1289, is the first D. & R.G.W. westward signal, and this signal is controlled by track occupancy of track circuits ahead except that if hand-throw switch No. 4 is reversed then signal 1289, is controlled to the Stop aspect, and signal 1289A takes over the controls which previously applied to 1289.

Eastward signal 1288A normally displays the Stop aspect, but if switch No. 6 is reversed and the lever is thrown, this signal displays a proceed aspect. On the other hand, if switch No. 4 is thrown to the reverse posi-

1282A governs trailing moves from the "River" track to the main line through the spring switch. Signal 1281 normally governs on the main track.

Signal 1281 has a lower unit which when illuminated displays the letter "S". When the letter "S" is illuminated, only possible with upper unit displaying Stop; it indicates: "Westward D. & R.G.W. trains take siding via River track and westward D. & S. L. trains take siding via Orestod siding."

R.G.W. main line west from Orestod, is normally set for train movements through the junction on the D. & S.L. track. This No. 6 switch is located directly in front of the office, and is thrown to the reverse position by the operator when a D. & R.G.W. train in either direction is to pass through the junction.

Signal 1287 governs westward train movements via switch No. 6 normal to the D. & S.L., or via switch No. 6

tion, then signal 1288A displays a proceed aspect, independent of lever control. The switching moves out of the two interchange tracks are governed by signals 1287A and 1288B.

At the east end of the "River" track, eastward signal 1282 governs eastbound main line moves, and

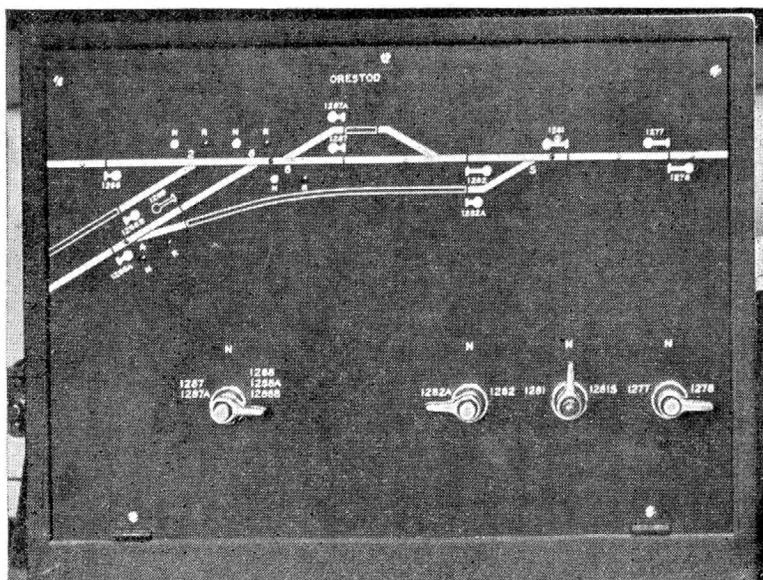
Face of panel on the interlocking control machine

The 10 semi-automatic signals and the take-siding "S" indicator are all controlled by only 4 three-position levers. The levers normally stand in the center position to control the corresponding signals to the Stop aspect. The first lever when thrown to the left controls signal 1287 or 1287A, depending on the selection established by the position of switch No. 8. The same lever when thrown to the right controls signal 1288, 1288A or 1288B, the selection between 1288 and 1288B depending on the position of switch No. 2, with No. 6 normal, and the selection between 1288 and 1288A depends on the position of switch No. 6

with No. 2 normal. When switch No. 4 is reversed, signal 1288A is independent of lever control.

The second lever when thrown to the left clears signal 1282A, or when thrown to the right clears 1282. The third lever when thrown to the left clears 1281, or to the right causes the "S" take-siding indicator to be lighted. The fourth lever when thrown to the left clears signal 1277 or when to the right clears 1278.
