Electric plant at Kankakee, Ill., built in 1903, has been replaced with new switch machines, signals, miniature lever machine, new circuits and plug-in relays

All-Relay

Interlocking on I.C.

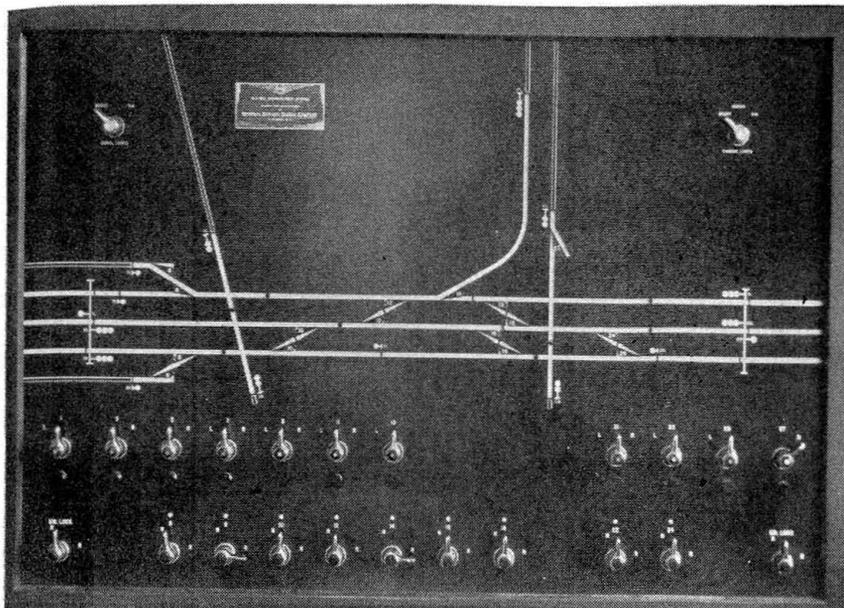
Above—The panel of the new interlocking machine includes the levers, track diagram, and various indication lamps. Right—View looking north at the northward home signal bridge of the interlocking

The switch levers, which are in a row at the bottom of the panel, are normally in the vertical position, being thrown 90 deg. to the right to control a switch to the reverse position. Above each switch lever there

is a small yellow lamp which is lighted during the time a switch is not over and locked in the position corresponding with that of the lever, thus such a lamp would be lighted when a switch is being operated, or it would stay lighted if the switch did not lock up. In the face of the barrel of each switch lever there is a red lens which is lighted during the time that electric locking is in effect to prevent operation of the switch even if the lever were thrown. In such an instance, the switch would not operate even after the locking is no longer effective, but rather the lever would have to be restored to

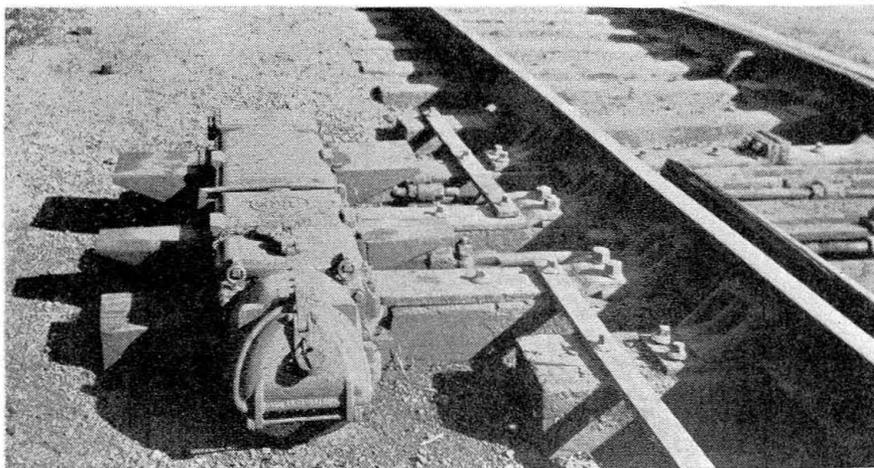
Modern switch machines were a part of the improvement program

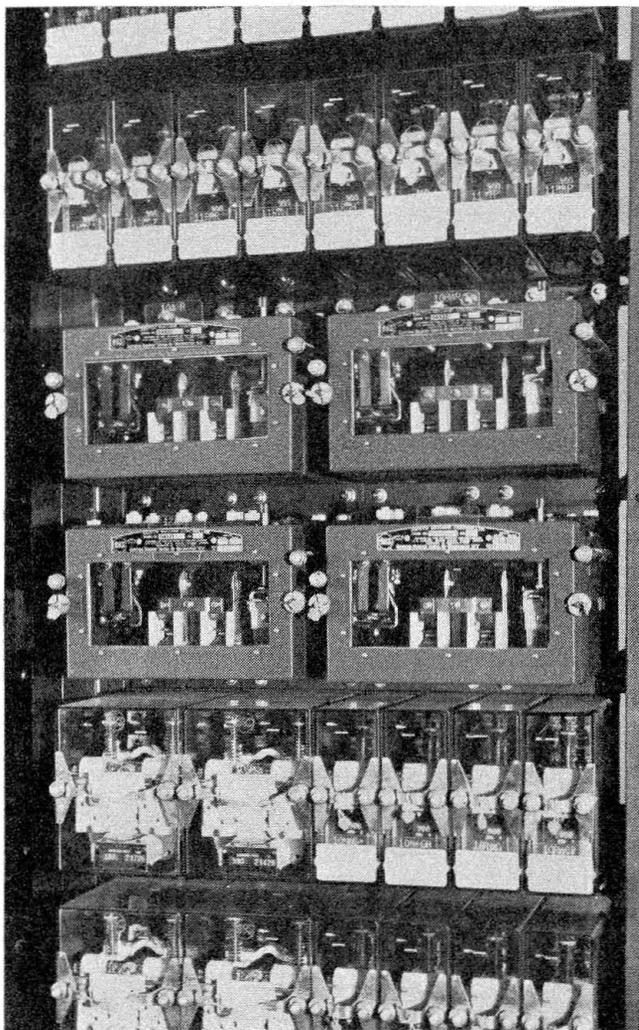
Typical section of plug-in relays

tower, including the motor-driven time-element relays, are of the plug-in type, as shown in the pictures.

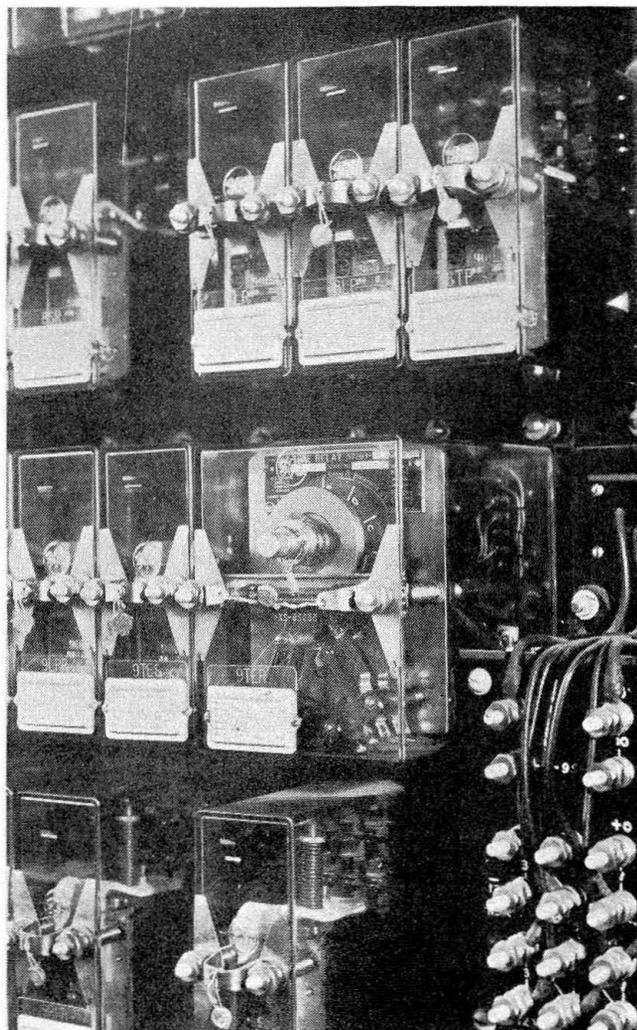
The time-element relays are also the plug-in type
