Inevitable Accident?

Should Sidings Have Circuits?

Accident #2: Similar Conditions

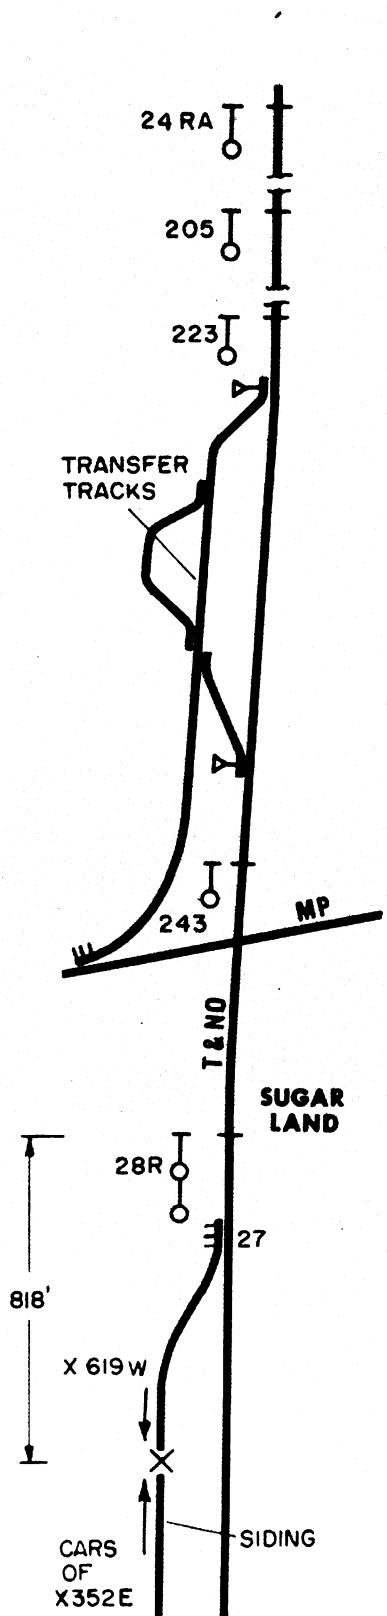
In the vicinity of the point of accident this is a single-track line over which trains are operated by the signal indications of a traffic control system. The switches at both ends of the siding at Sugar Land are powered by

The control machine, located at Houston, is of conventional design, with three-position signal levers and two-position switch levers. A train graph is provided. Signal indications and operating rules which pertain to this investigation are:

gine crew next observed signal 28R indicating Proceed on Diverging Route at Restricted Speed, and this indication was called between the members of the engine crew. The engineman said that he assumed from this indication that the rear portion of X352E, whose locomotive he had seen on the transfer track, was occupying the main track and that the dispatcher had routed his train onto the siding to permit it to pass. He said that he continued to apply the independent brake as the train entered the siding, and that the speed was reduced to 27 mph. He said that he was unaware that the siding was occupied until the locomotive had traversed the turnout and the headlight beam shone upon the cars at a distance of about 350 ft. He initiated an emergency application of the brakes, but the collision occurred before the speed was materially reduced.

After the accident occurred, an inspection of the portion of the signal system involved, including the traffic control machine, disclosed no defect which could have contributed to or caused the accident. Although the graph of the traffic control machine does not record the positions of switches, it is evident from an analysis of the graph, however, that the train dispatcher inadvertently re-established the route for a westward movement onto the siding, instead of on the main track while switch 27 was locked in the reverse position.
